Manhole Inspection Summary

Manhole # S11MM_012MH

Insp Date: **8/21/07 5:33 PM**

Location Address: **2939 GWYNNS FALLS PKWY**

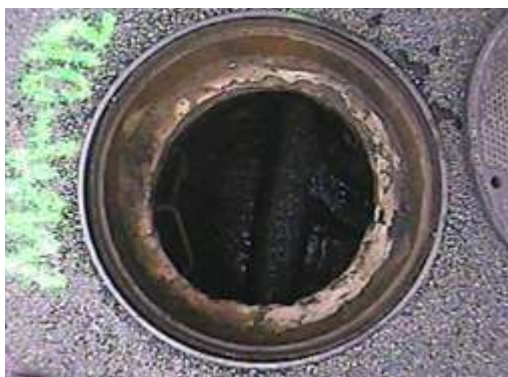
Top View

Offset: **4** (in.)

FRAME OFFSET.

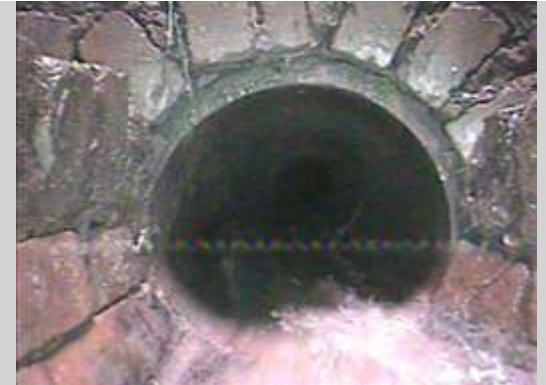
12 O'Clock Outflow

10 in. Circular Gravity Sewer
Pipe Out @ 12 O'Clock

Pipe Height: (in.) Direct
Pipe Material: **Clay** ☐ Pipe Lined
Invert Depth: **7.14** (ft.) Flow Characteristics: **Fast**
Deposits: ☒ None ☐ Mud ☐ Sludge ☐ Debris ☐ Grease
Silt Depth: (in.) Deposits Extent:
Infiltration: **None** Pipe Seal Cond: **Sound**

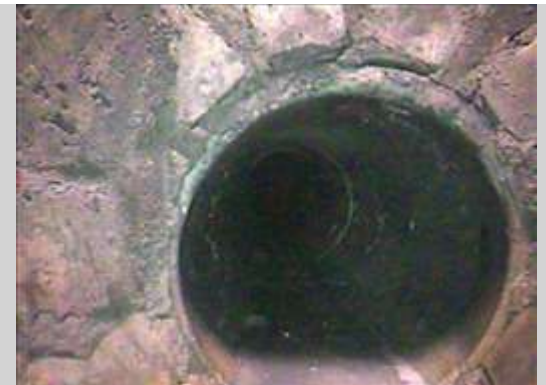
3 O'Clock Inflow

8 in. Circular Gravity Sewer
Pipe In @ 3 O'Clock

Pipe Height: (in.) Direct
Pipe Material: **Clay** ☐ Pipe Lined
Invert Depth: **7.10** (ft.) Flow Characteristics: **Slow**
Deposits: ☒ None ☐ Mud ☐ Sludge ☐ Debris ☐ Grease
Silt Depth: (in.) Deposits Extent:
Infiltration: **None** Pipe Seal Cond: **Sound**

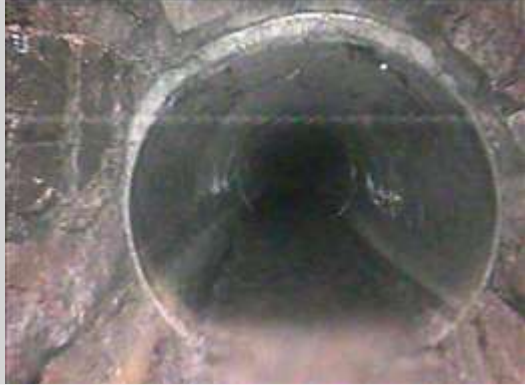
6 O'Clock Inflow

10 in. Circular Gravity Sewer
Pipe In @ 6 O'Clock

Infiltration: **None** Pipe Seal Cond: **Sound**
